STATE OF MARYLAND
BOARD OF NATURAL RESOURCES
DEPARTMENT OF GEOLOGY, MINES AND WATER RESOURCES
JOSEPH T. SINGEWALD, JR., *Director*

BULLETIN 6
SHORE EROSION
IN
TIDEWATER MARYLAND

1949

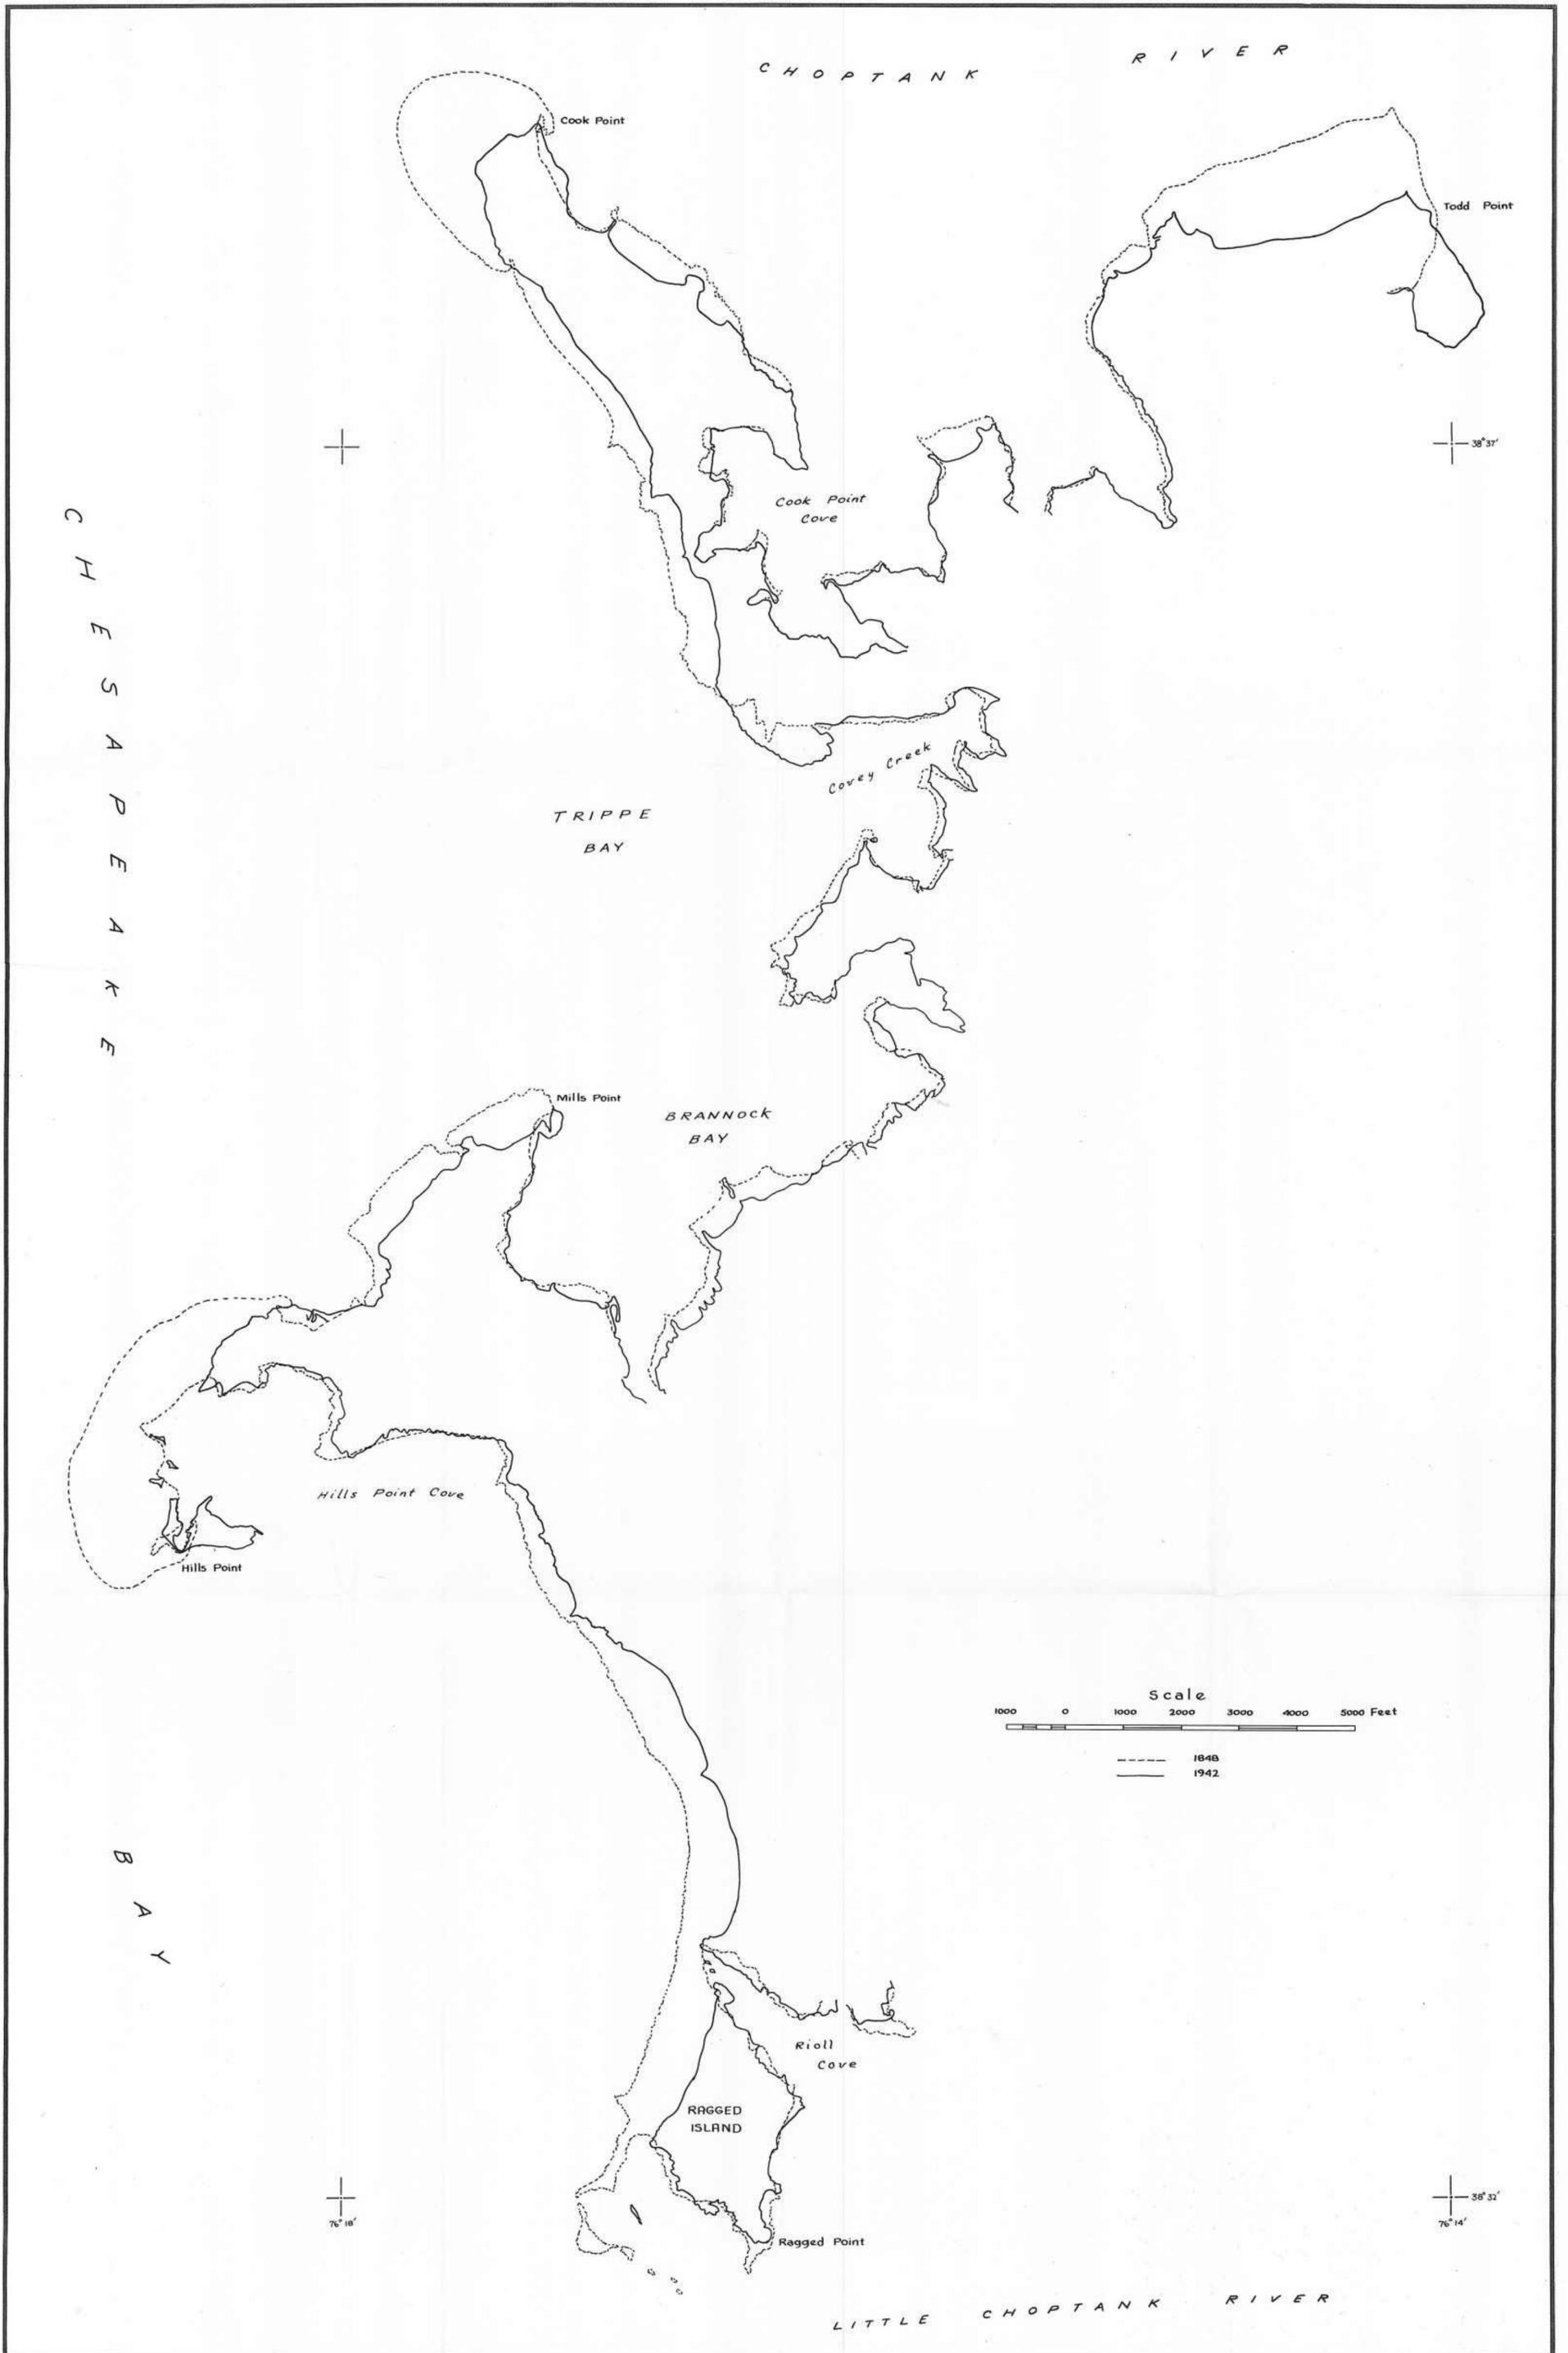
PLATE 11. Shore Line Changes from Todd Point to Rioll Cove, Dorchester County

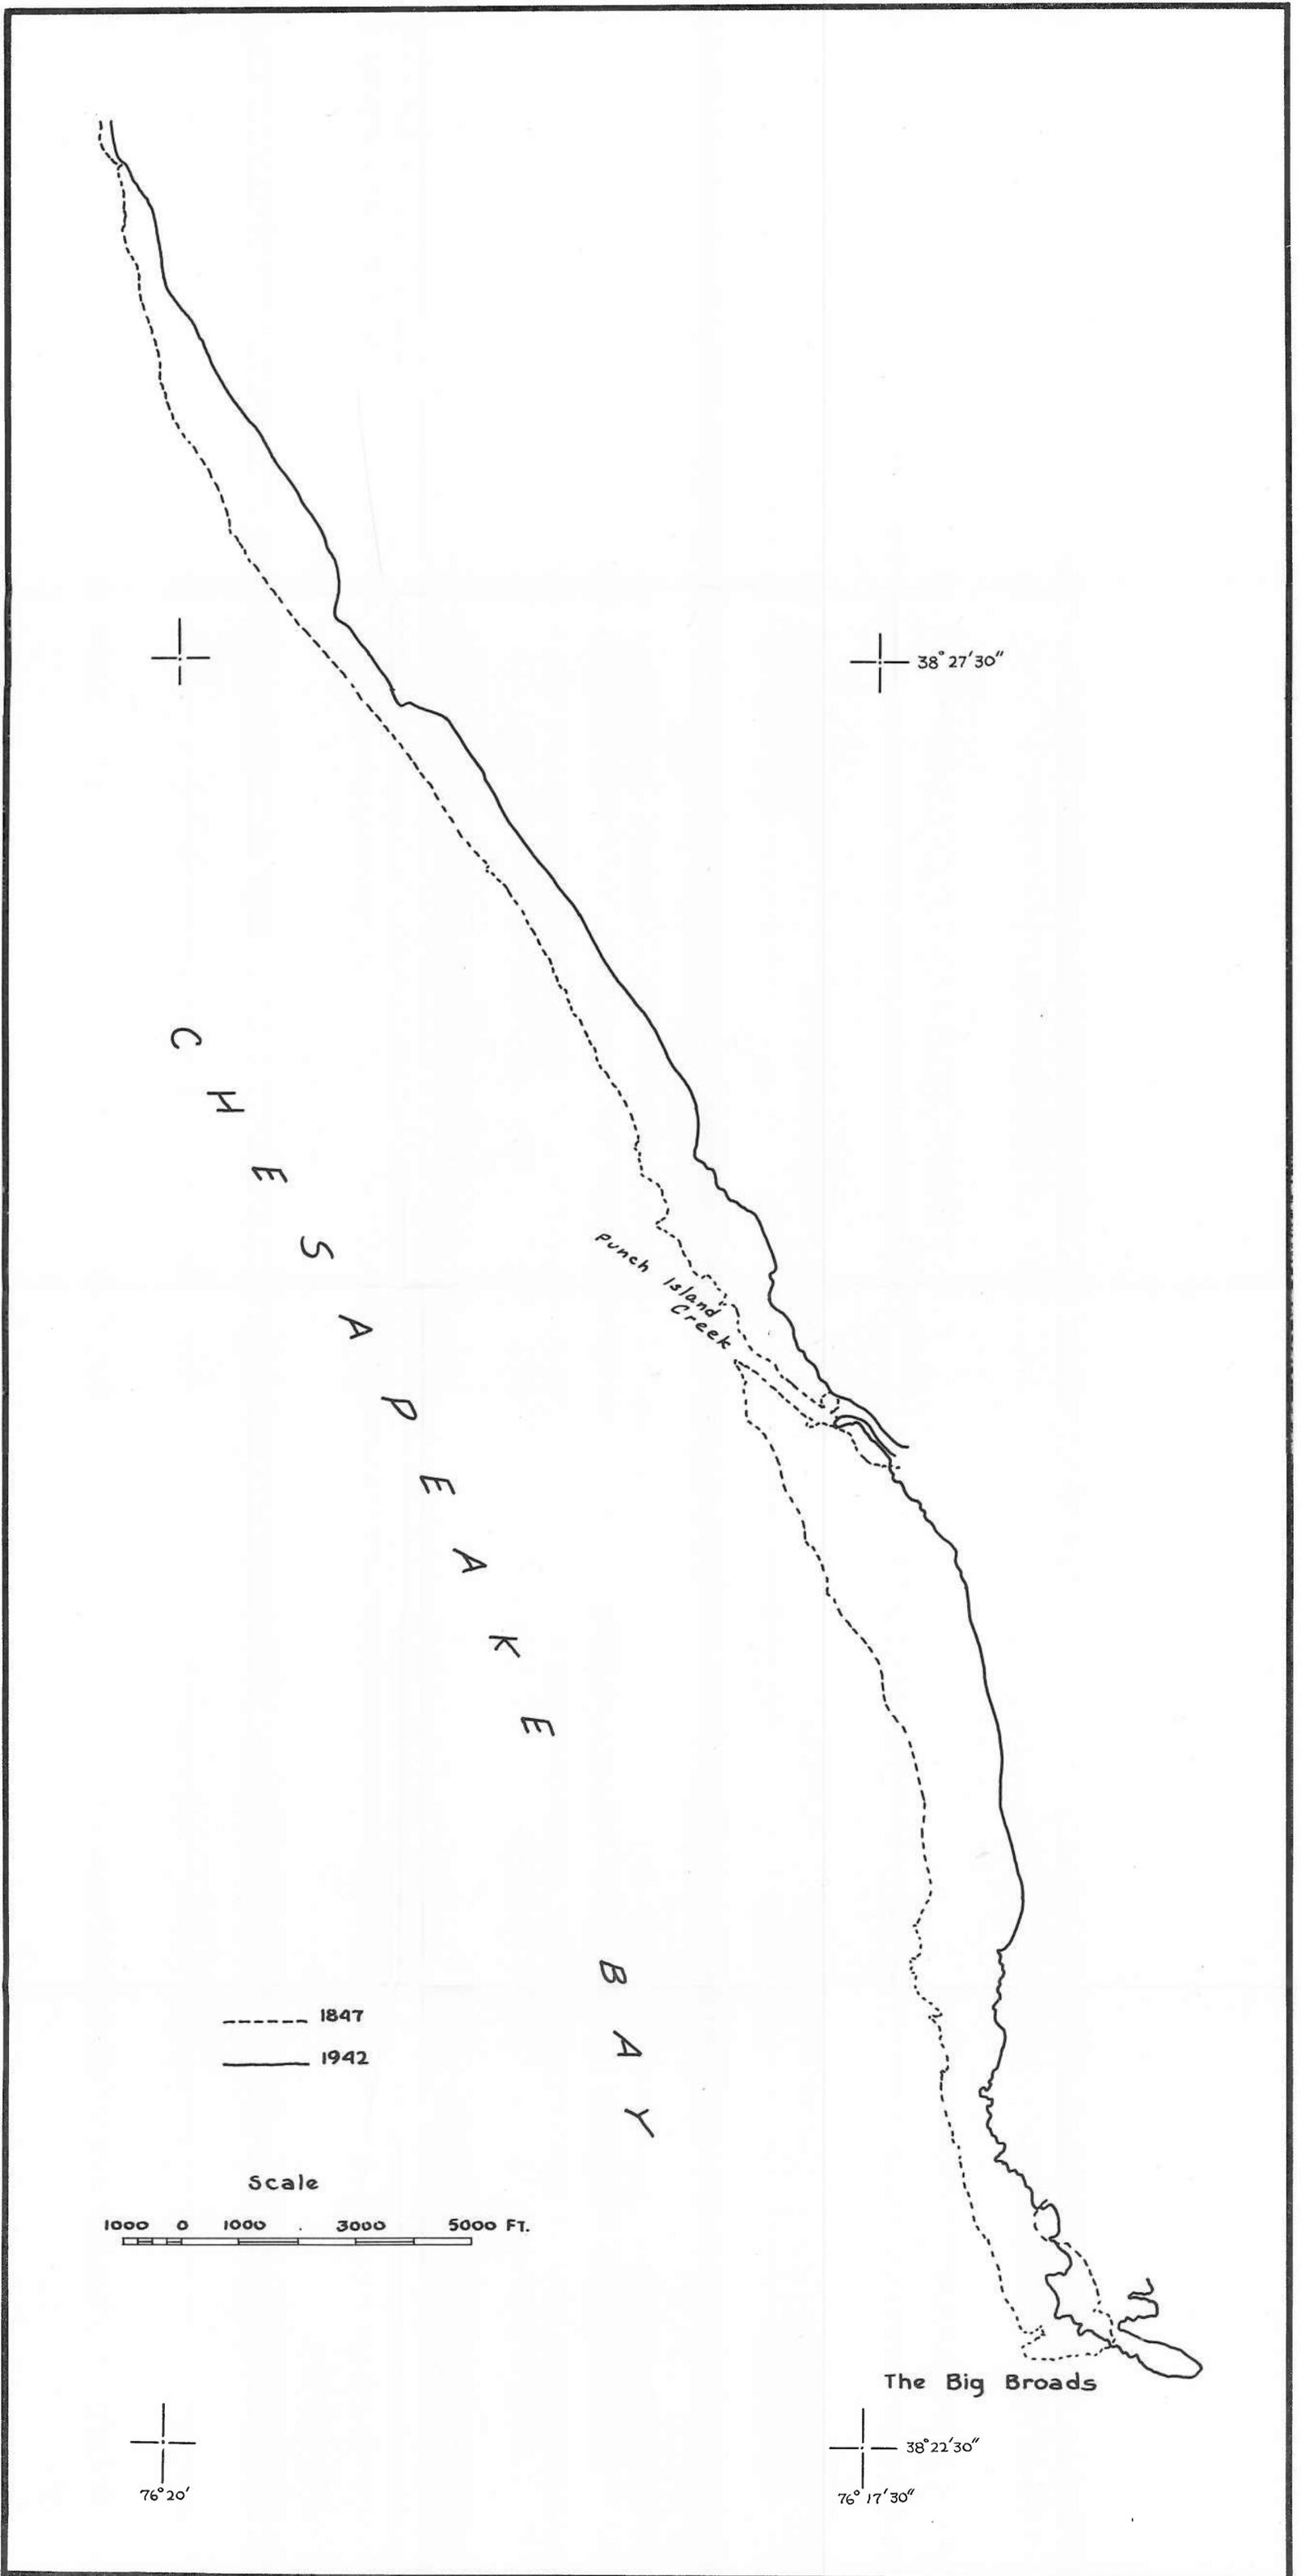
PLATE 12. Shore Line Changes from 1 Mile South of Oyster Cove to the Big Broads, Dorchester County

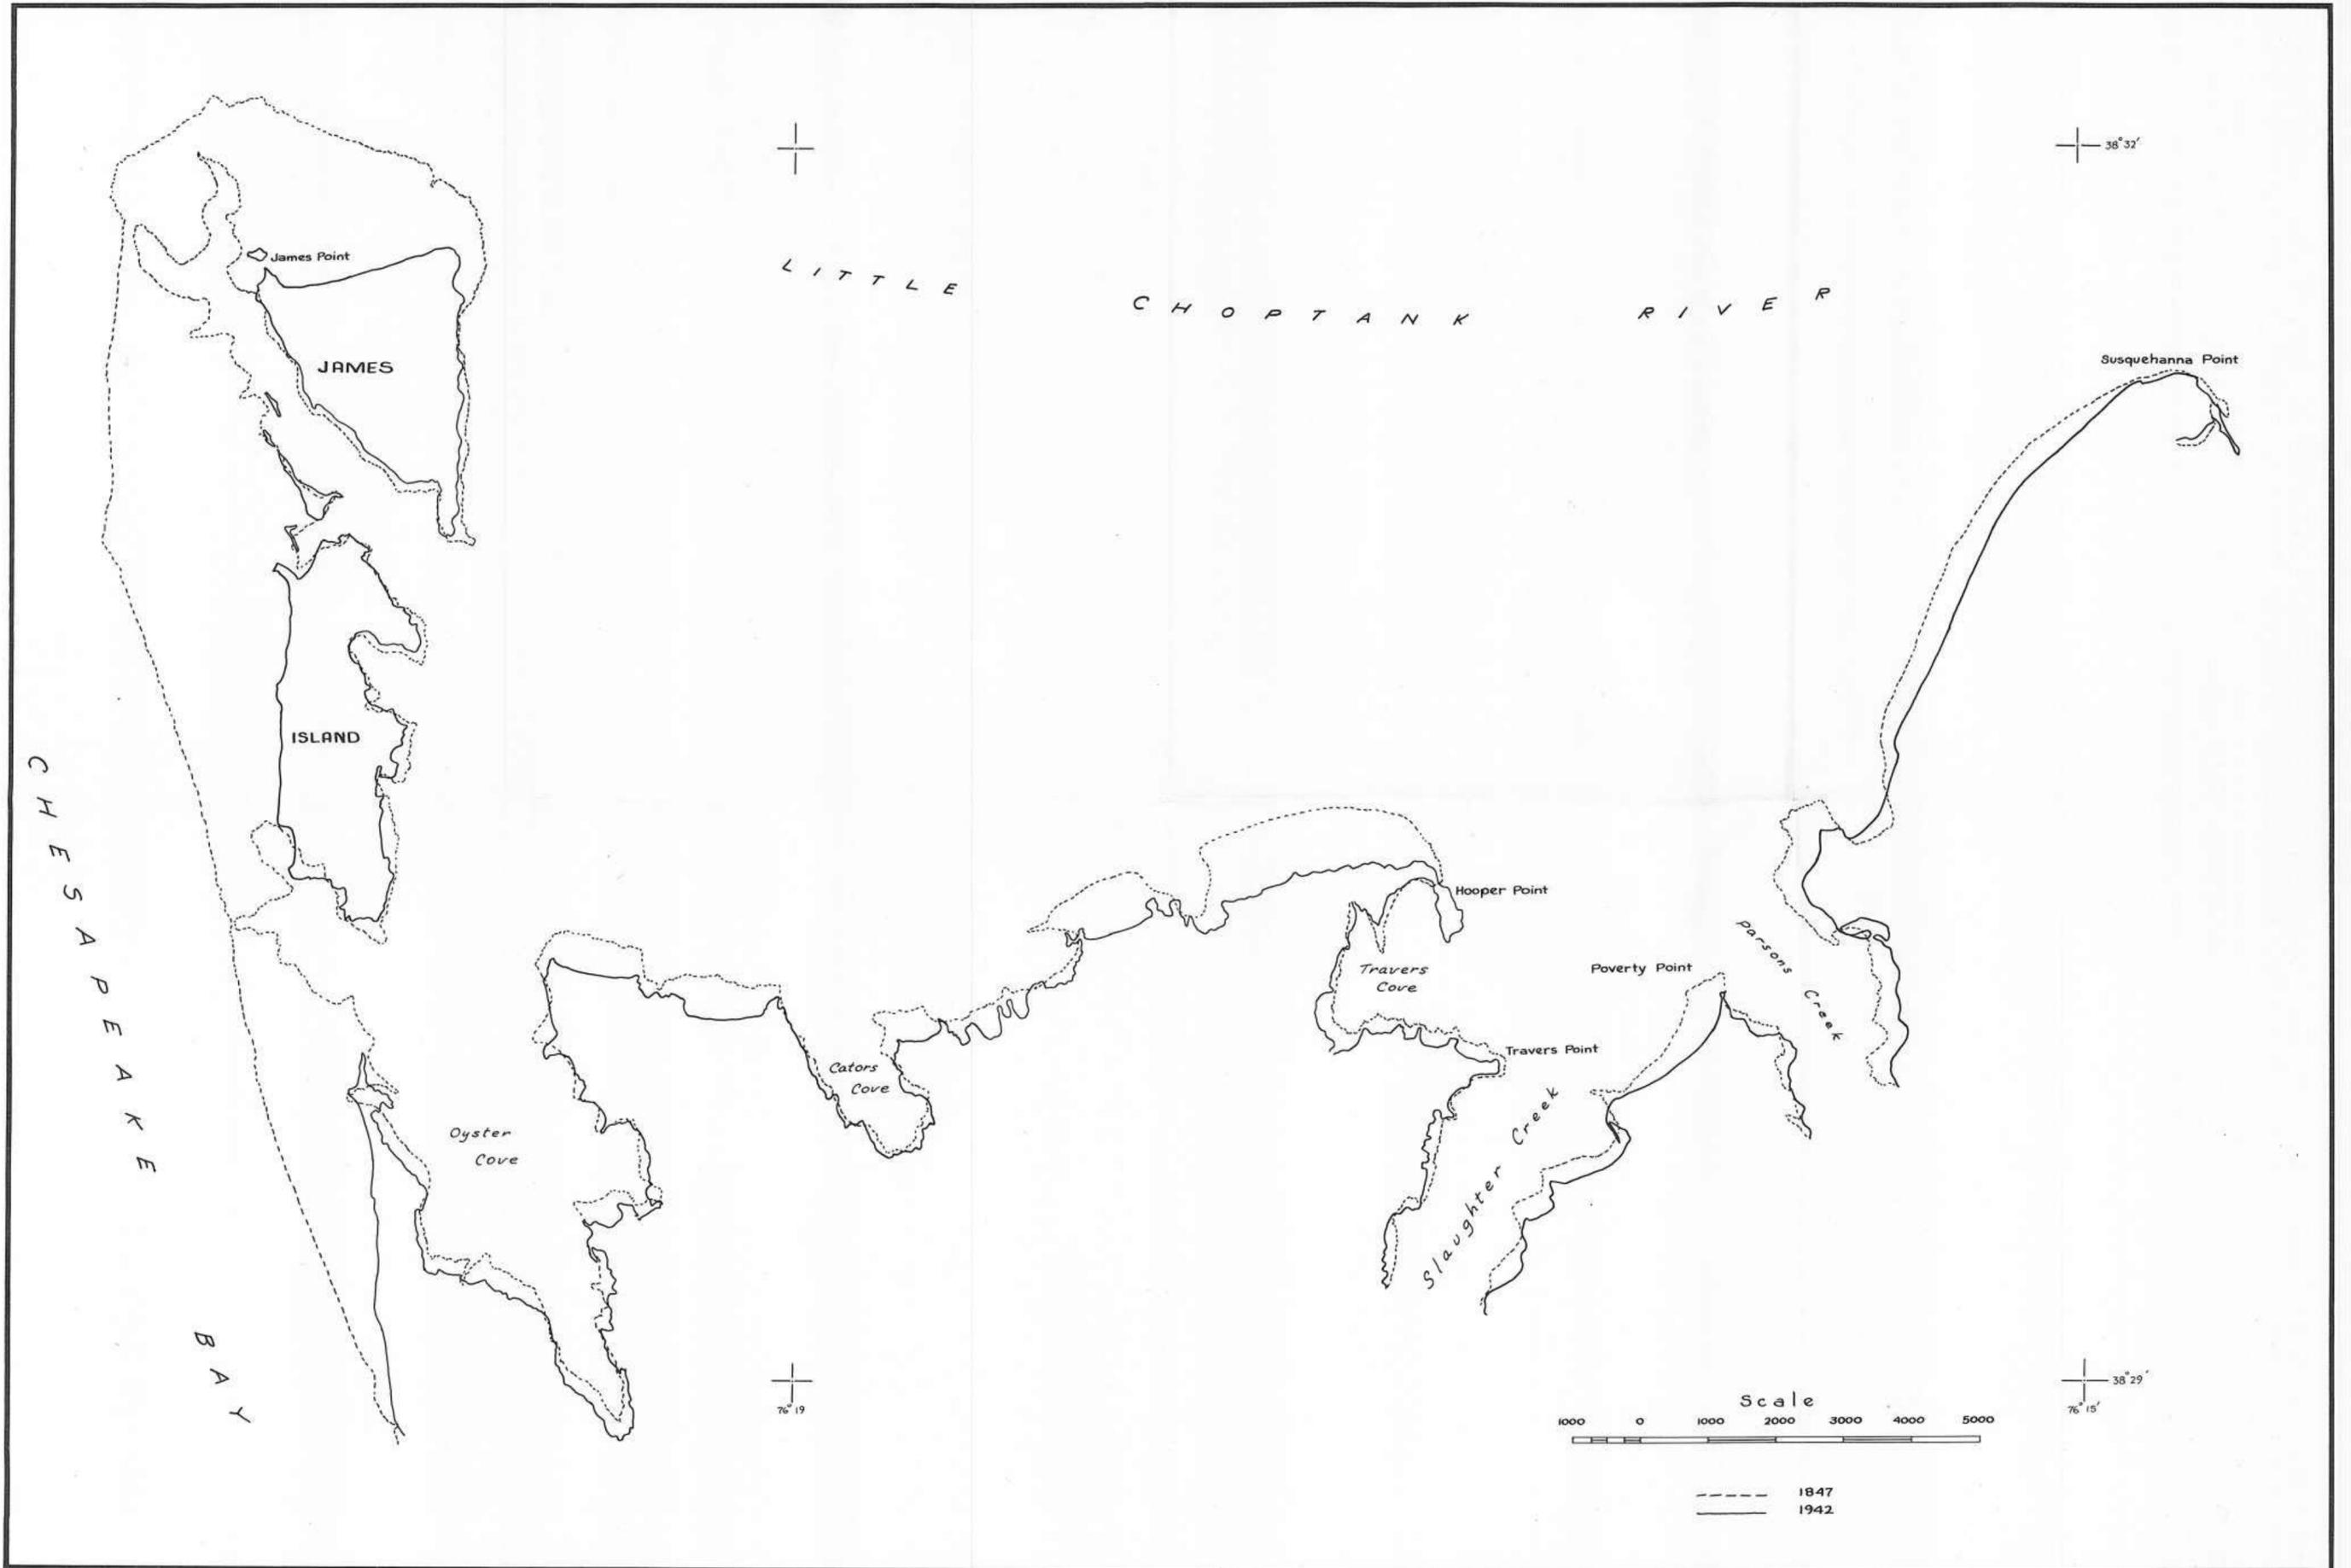
PLATE 13. Shore Line Changes of James Island and from Susquehanna Point to 1 Mile South of Oyster Cove, Dorchester County

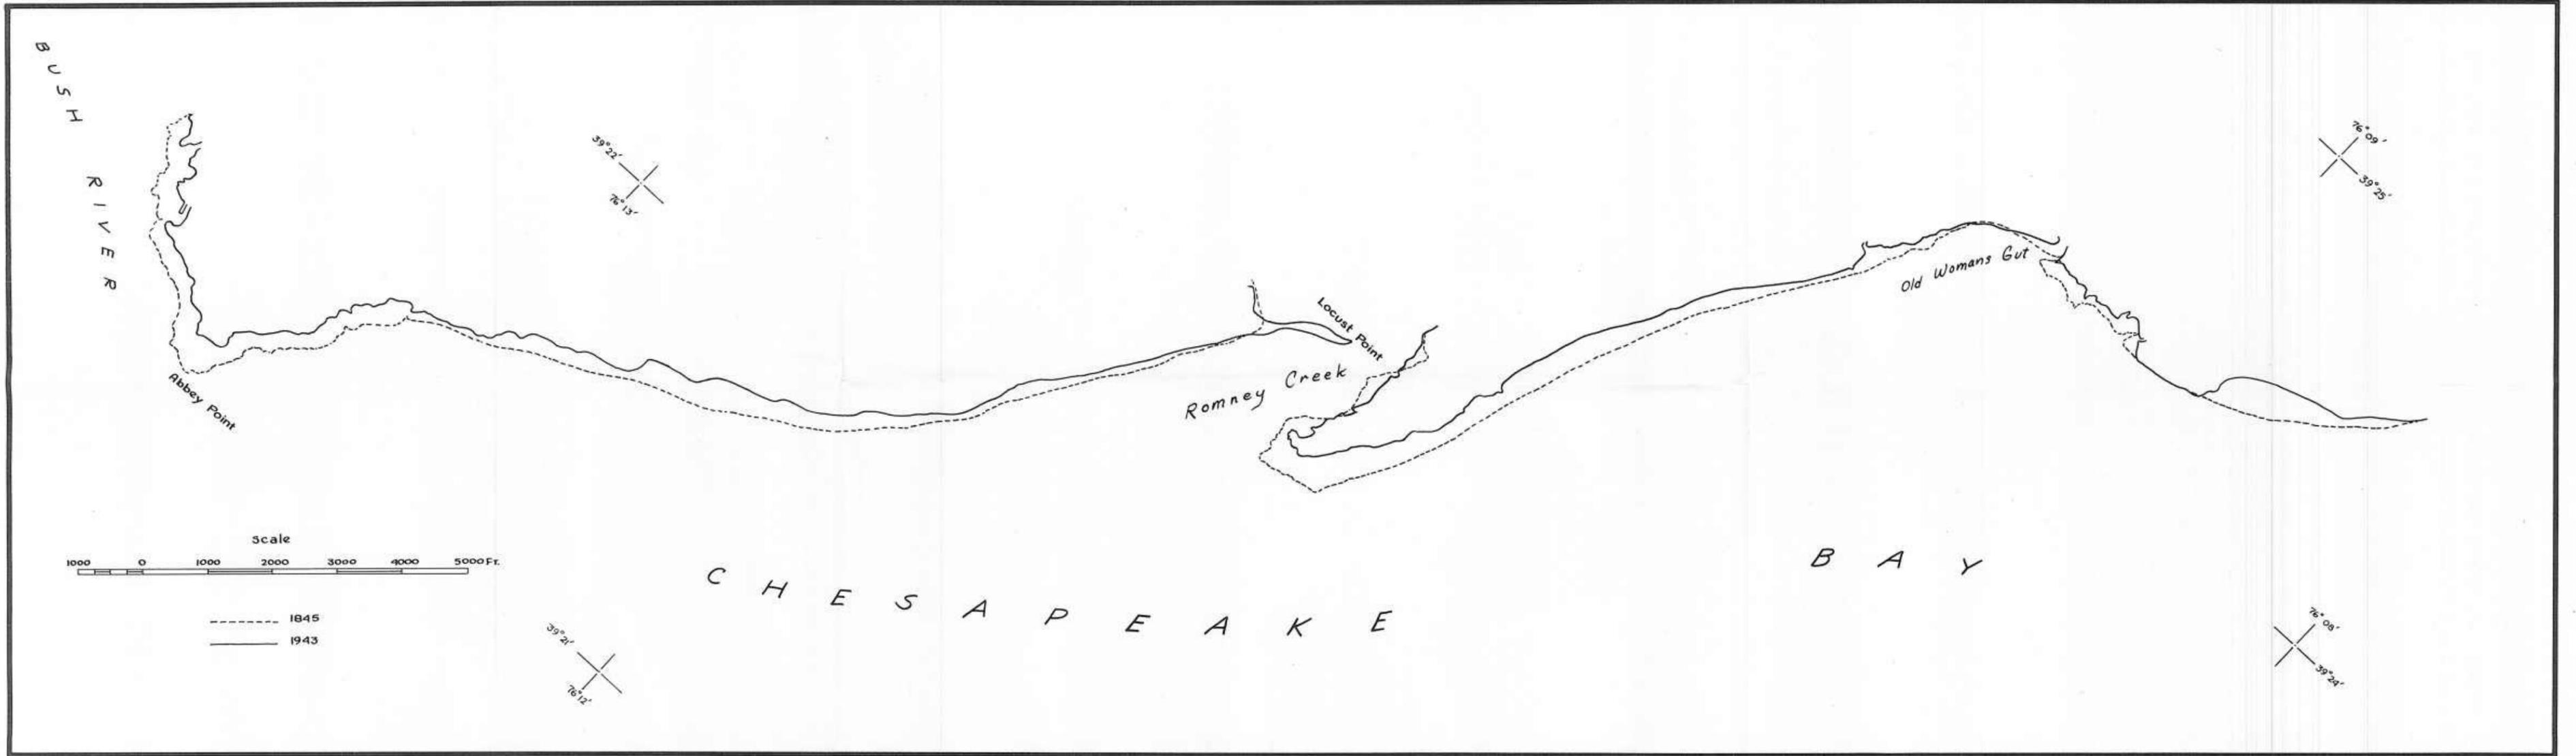
PLATE 14. Shore Line Changes from Old Womans Gut to Abbey Point, Harford County

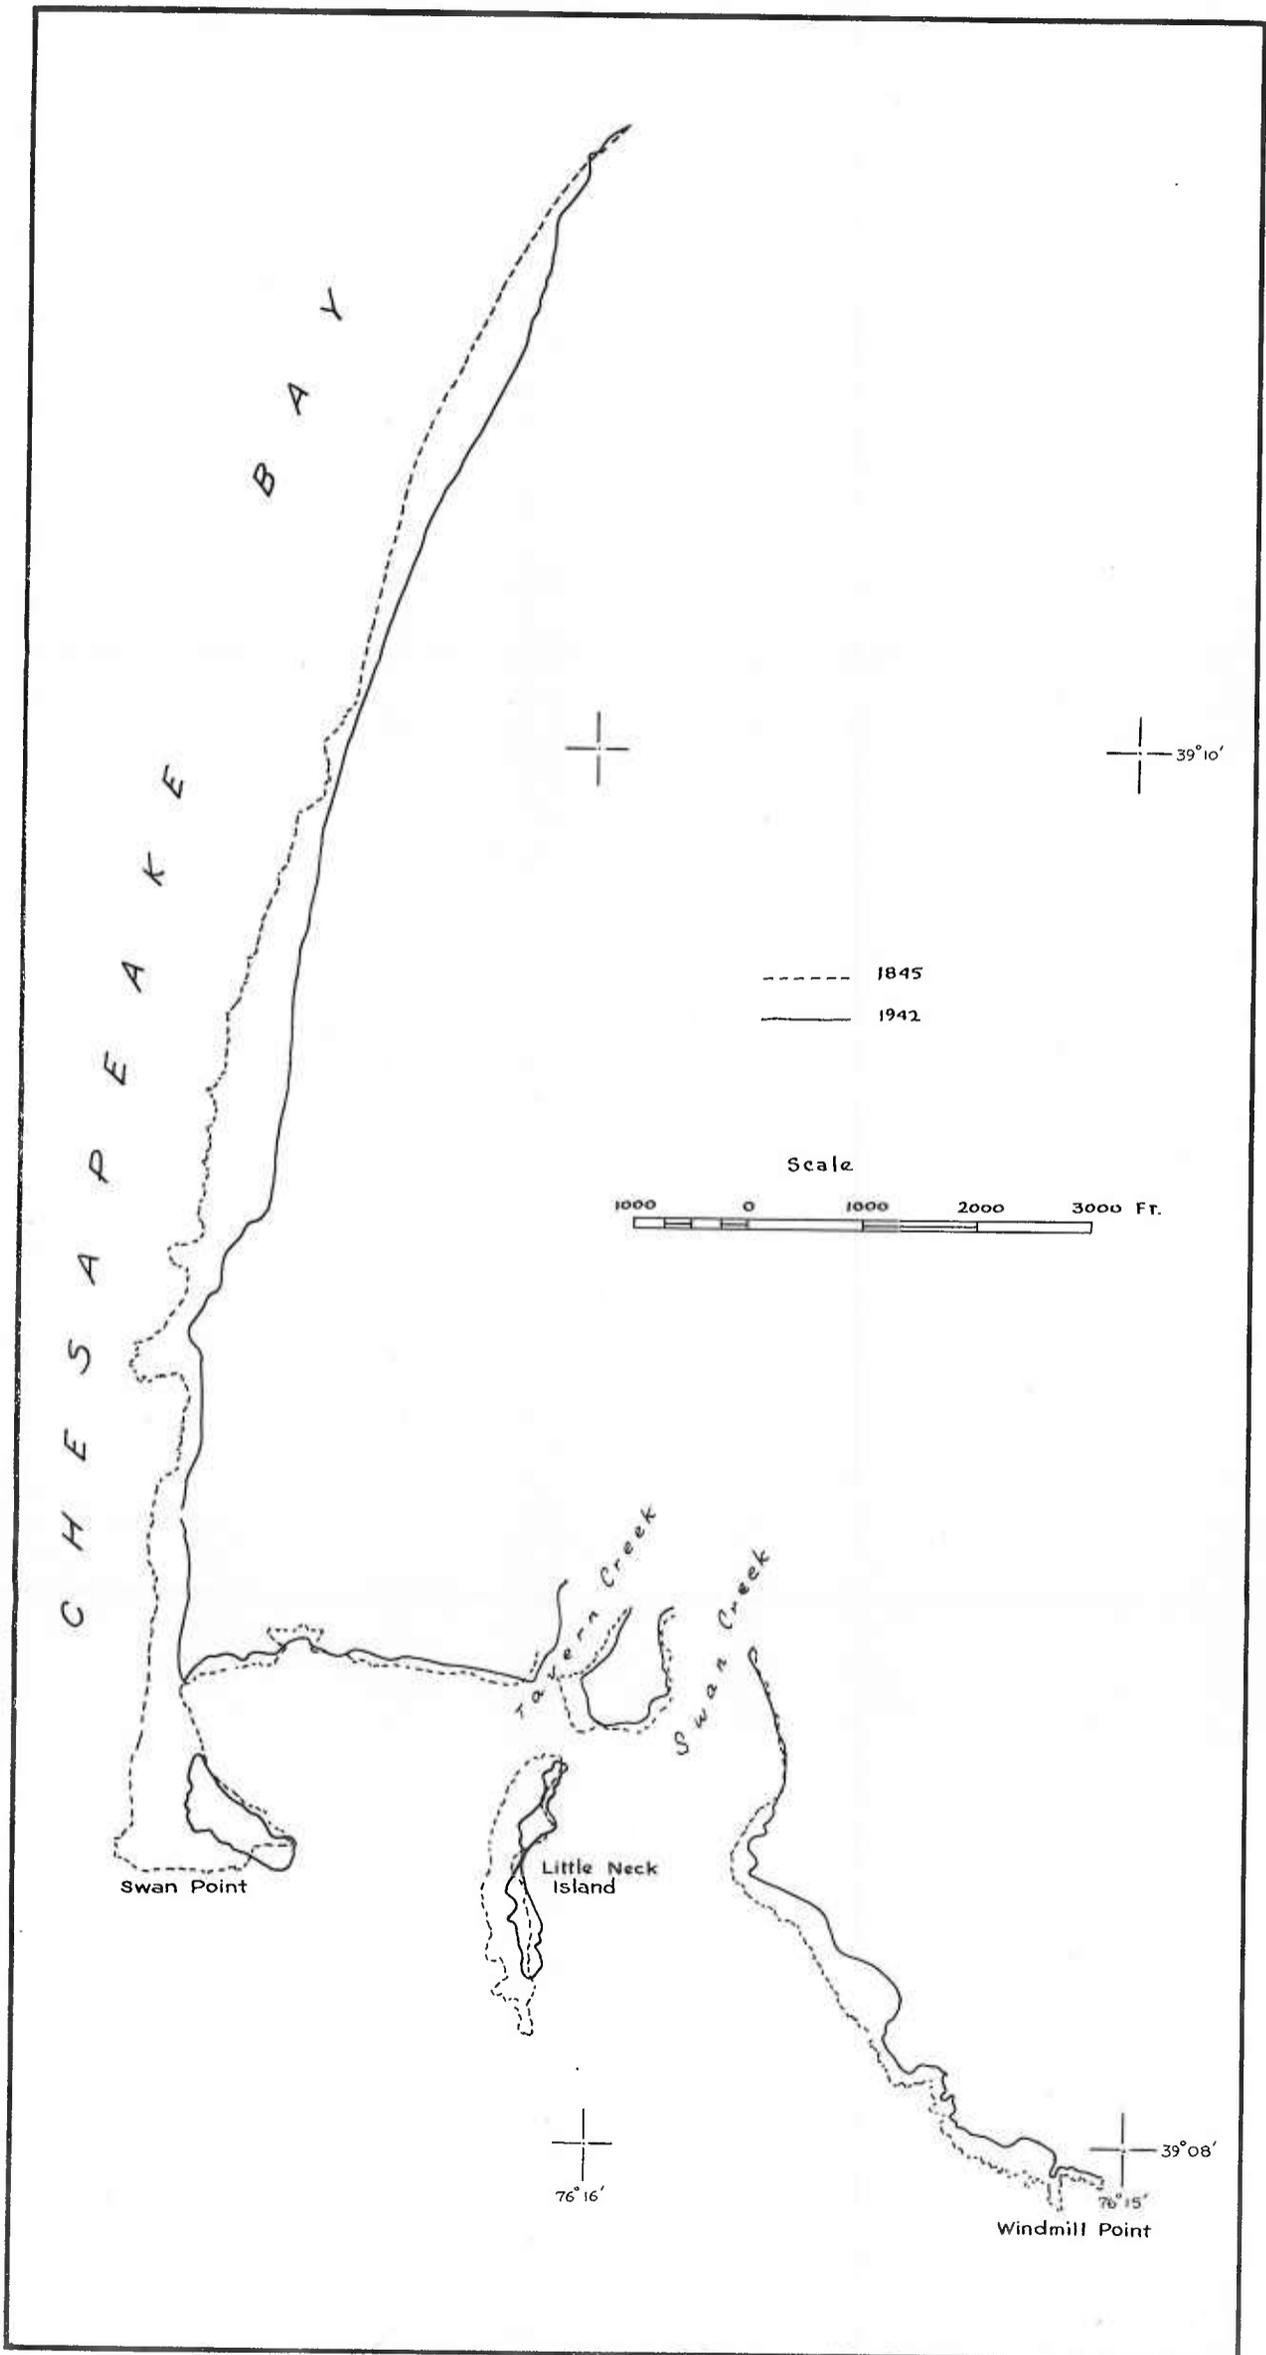
PLATE 15. Shore Line Changes from 2 Miles South of Tolchester Beach to Windmill Point, Kent County

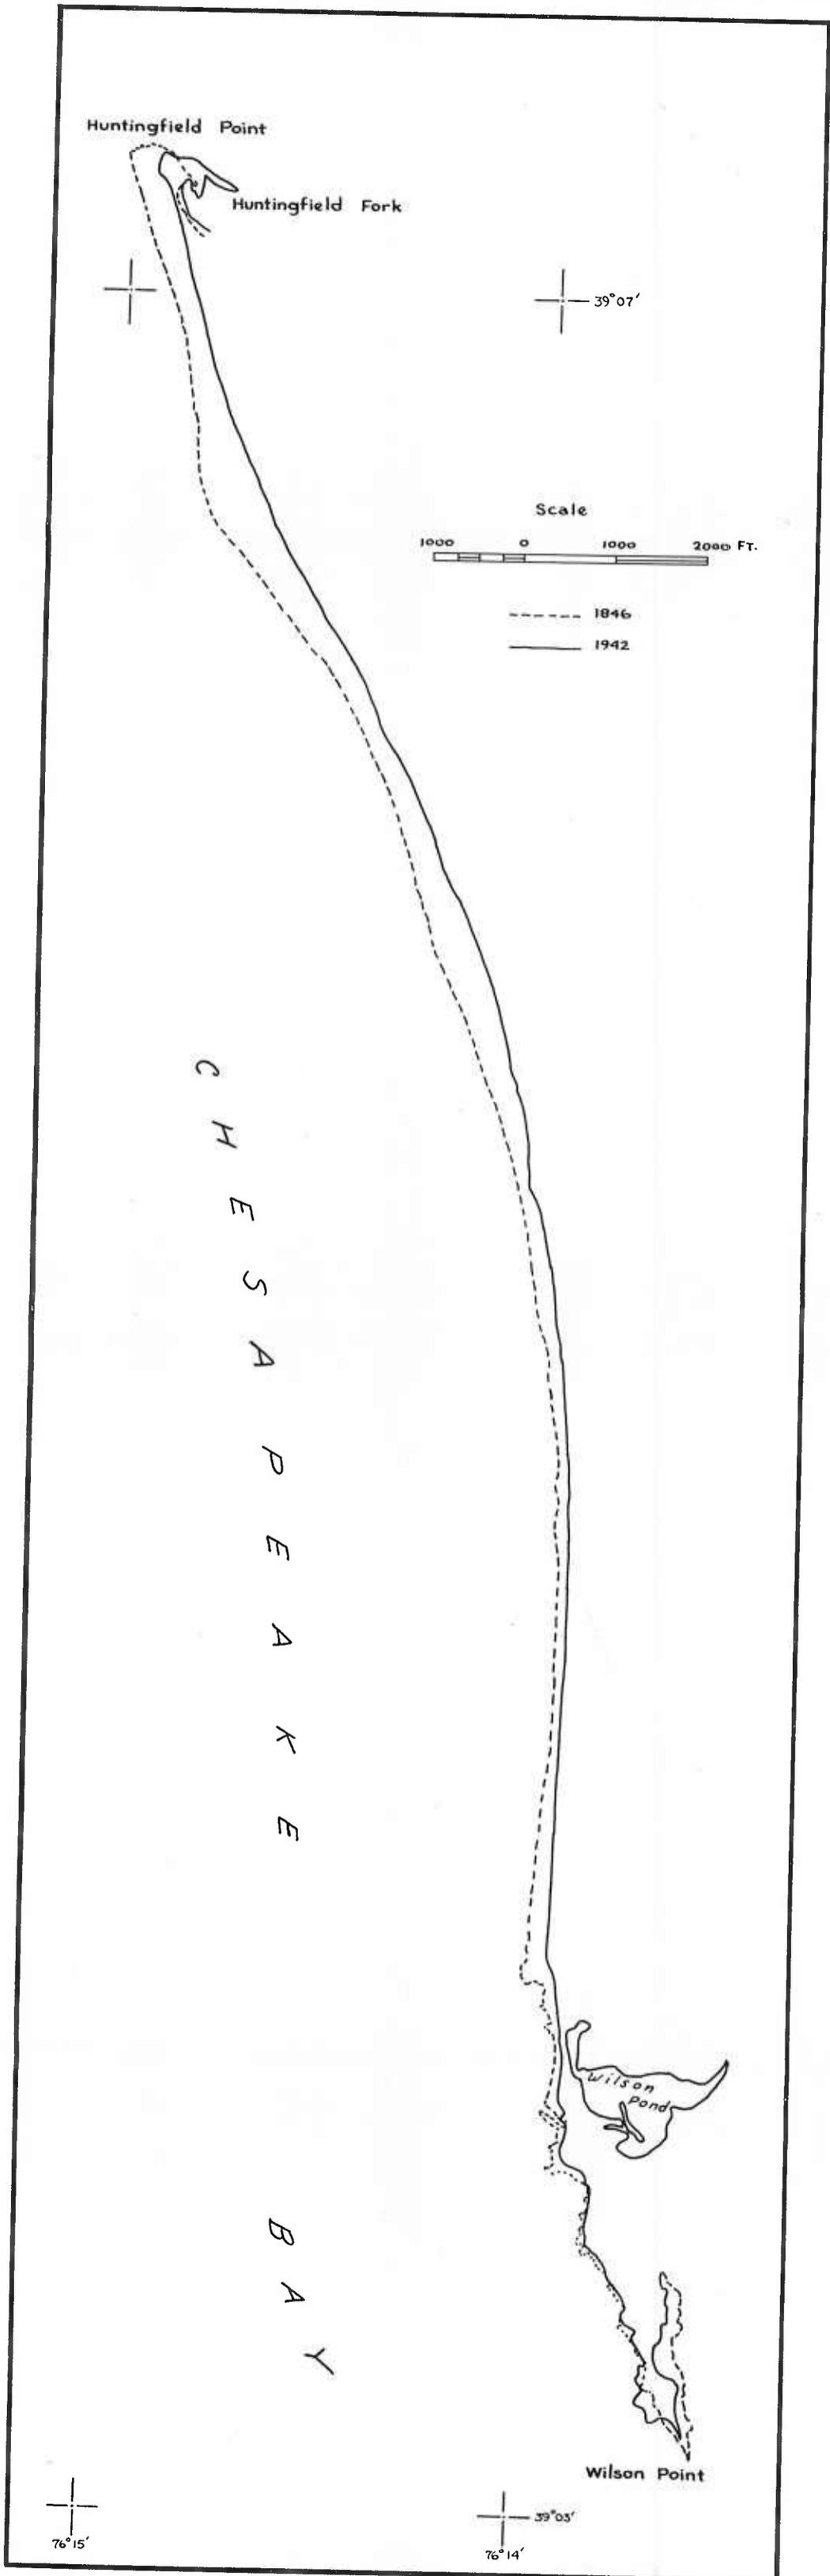
PLATE 16. Shore Line Changes from Huntingfield Point to Wilson Point, Kent County

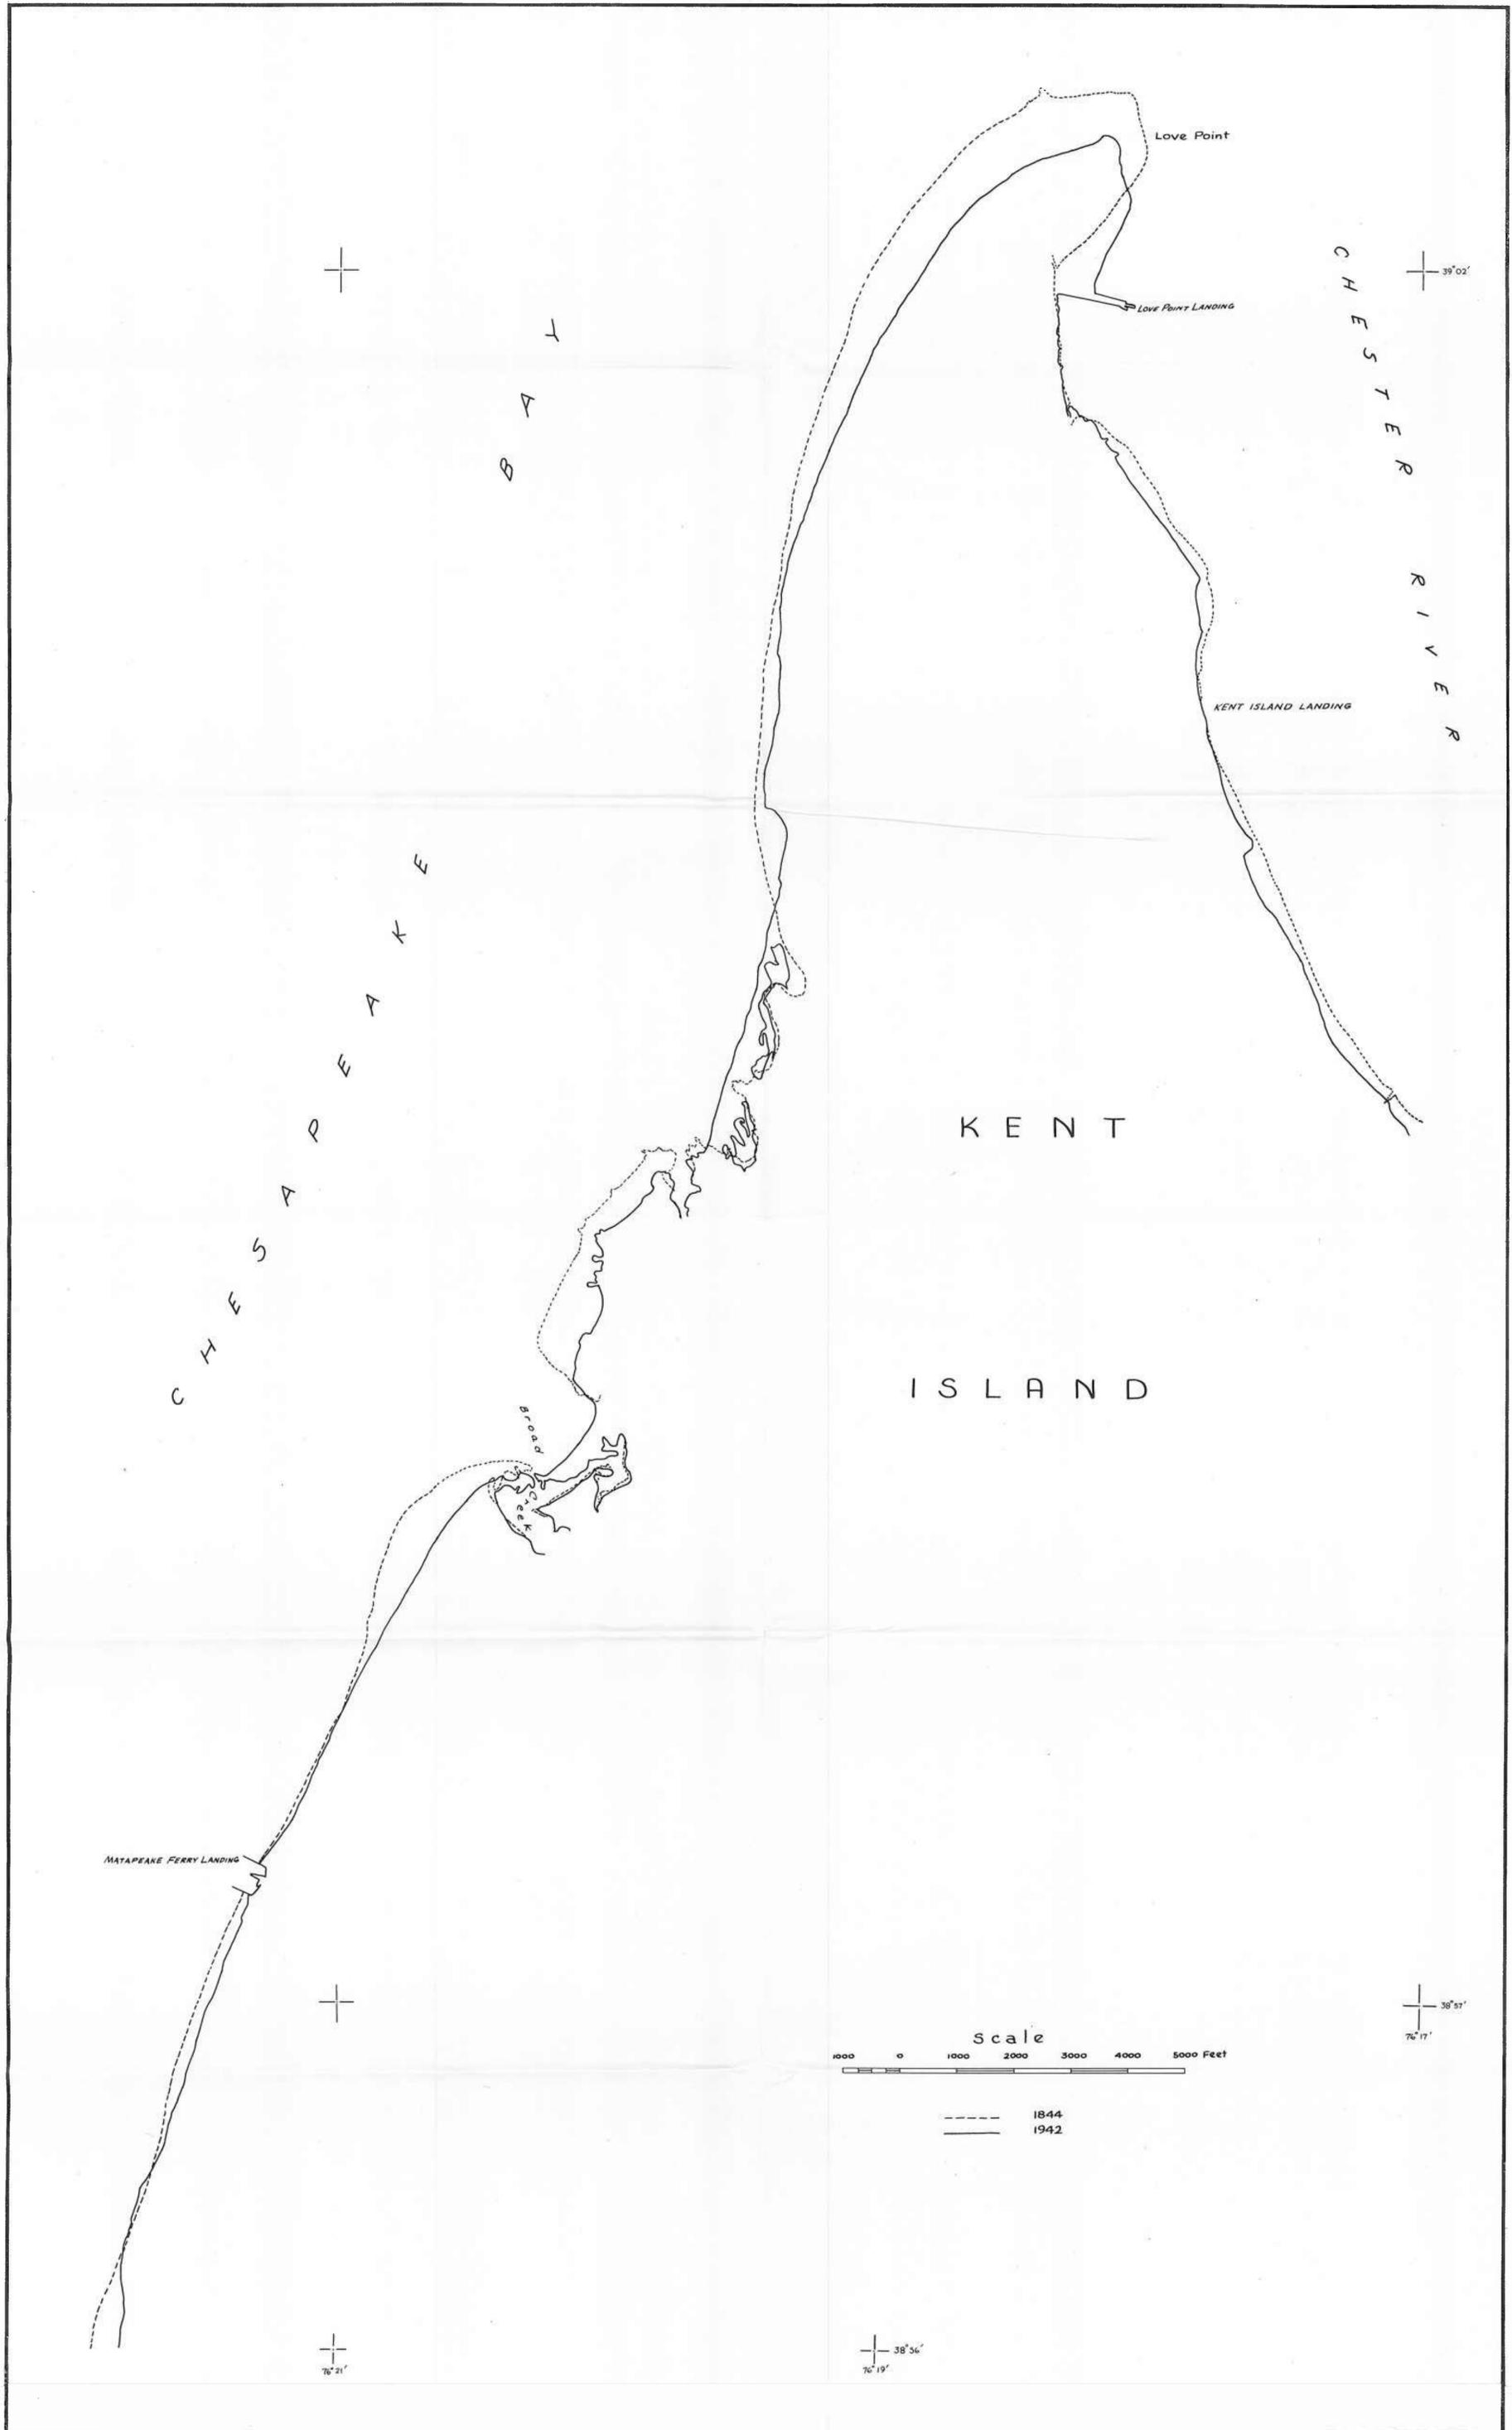
PLATE 17. Shore Line Changes from Love Point to 1 1/2 Miles South of Matapeake Ferry Landing, Queen Annes County
